Manhole Inspection Summary

Manhole # S35AA1007MH

Insp Date: **3/26/07 8:54 AM**

Location Address: **110 34TH ST**

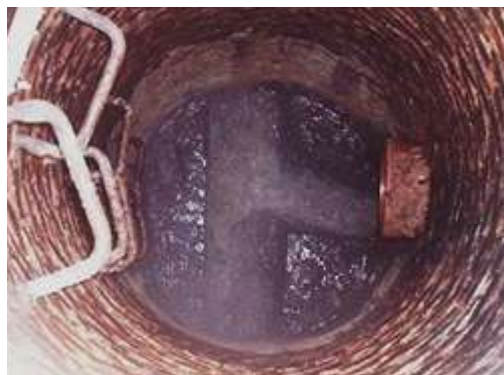
Top View

Barrel infiltration. Corroded steps. Bench debris.

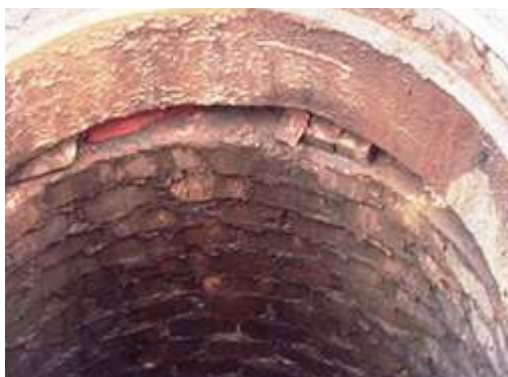
Defect

Frame leaks. Adjustment deterioration, loose brick and infiltration.

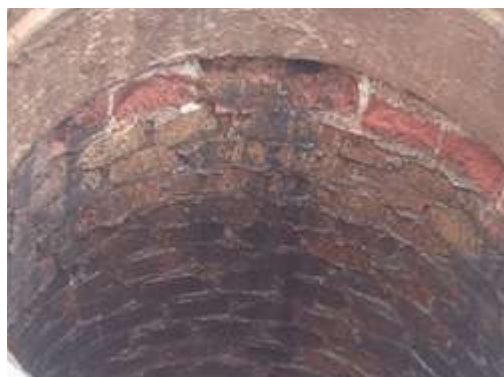
Defect

Frame leaks. Adjustment deterioration and infiltration. Corbel and Barrel infiltration.

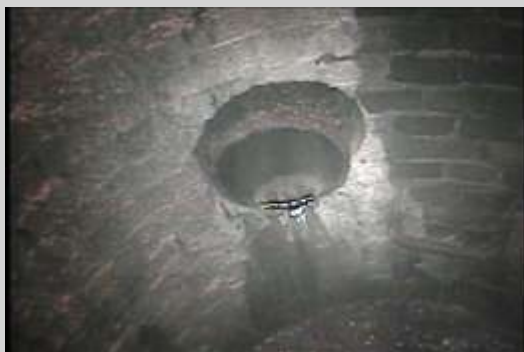
Pipe In @ 8 O'Clock

Comments **The l8 pipe seal is not flush to the pipe.**

Barrel infiltration.
